Service Information

TITLE : HWA 6D, HWA 14D new pump

MODEL : HWA 6D, HWA 14D

DATE : 2022-11-23 **NUMBER :** SI 221123

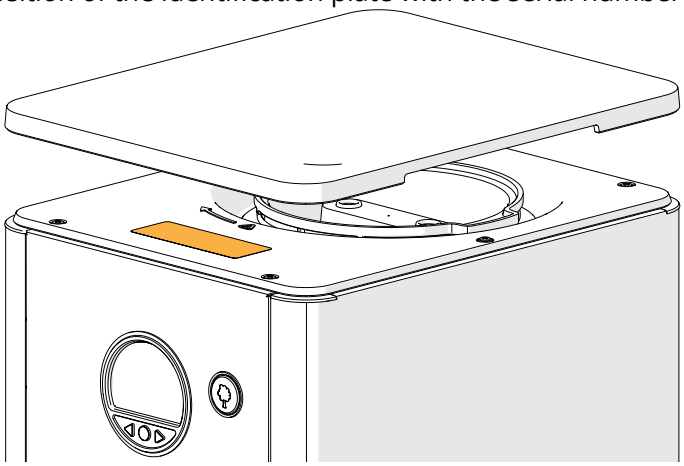
We have changed the pump of the HWA 6D and HWA 14D machines due to some issues with the pump.

Cause:
The old pump was in some cases causing extra noise and unintended error 9 messages.

Solution:
The new pump doesn't fit directly on earlier produced machines and because of this we have created a rebuild set of the new pump with some additional parts so that it can be used in earlier produced machines.
