Service Information

TITLE : Sprso water inlet change

MODEL : All Sprso models

DATE : 2022-01-25 **NUMBER :** SI 220125

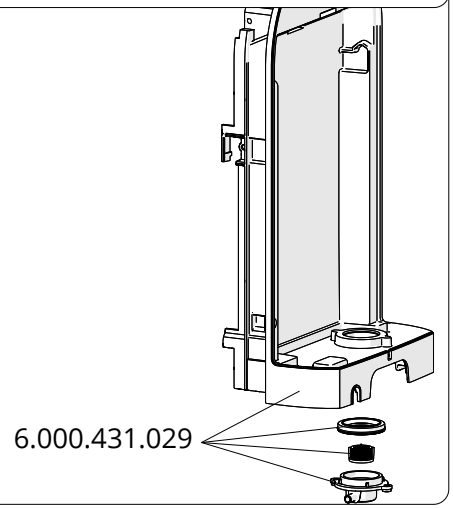
6.000.431.029 water inlet and housing set Sprso

Because of a change in the water inlet of the Sprso this part doesn't fit older Sprso machines.

Cause:
With the old water inlet it was possible to place the water tank incorrect on the machine which could cause a leakage between the water inlet and water tank.

Solution:
For this reason the dimensions of the water inlet and the housing of the Sprso are changed.
The old and new part can not be exchanged with each other as the fit would not be good.
We have created a set of parts that fit older Sprso machines in case these should ever be changed.

For machines with a lower serial number as of **020002238255** the set must be used.

The set contains:
- water inlet
- sealing ring
- sieve
- back panel
